Inspection of Babylon on behalf of UNESCO 25th 29th February 2009

Introduction

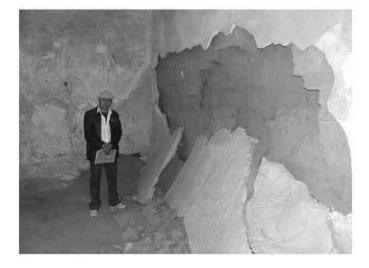
There is partial wall collapse in three different rooms of this reconstructed temple that is alleged to have happened since 2004 (Fig. 3). In each case sections of wall up to a depth of two rows of bricks have collapsed. The collapsed sections of wall are partly original and partly restoration, and were covered during the restoration with a thick coat of modern plaster. It is likely that it is the weight of this plaster that has caused the walls to collapse, probably combined with rainwater seeping into the middle of the wall through leaking roofs above. The collapses are as follows:

(i) In the room to the south of the smaller courtyard (Room 22). The area of collapse in the south wall is c. 8m long and c. 3m high, to a depth of two rows of bricks.

(ii) In the room to the north-west of the main courtyard (Room 9). The area of collapse in the east wall (north of the doorway) is c. 7m long and c. 2m high to a depth of one row of bricks. The north wall of this room is also ready to collapse.

(iii) In the room to the north-east of the main courtyard (Room 7). The area of collapse in the north wall (west of the doorway) is *c*. 5m long and *c*. 3m high to a depth of one row of bricks. In this case, the heavy plaster has been fixed on to the wall with modern iron pins driven into the ancient brickwork.

3. A collapsed wall in the Nabu- sha-hare Temple

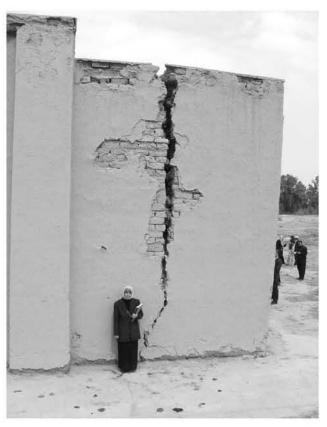
There is a bad crack in the outside wall of this reconstructed temple at the south-east corner of the building that needs urgent attention (Fig.4). In addition, replastering is badly needed (i) on the outer façade of the building on the east wall to the north of the doorway, and (ii) on internal walls throughout the building.

4. A crack in the wall of the Ishtar Temple

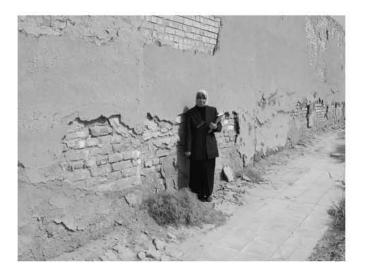
Both of the reconstructed Babylonian houses situated between the Nabu-ša-hare Temple and the Ishtar Temple are badly in need of external replastering (Fig. 5).

5. External wall of a Babylonian house in need of replastering
